HISTORIC STRUCTURE REPORT

Thomas H. Moore House
2201 Dixie Avenue SE, Cobb County
Smyrna, Georgia 30080-1578

Prepared for: Joel Powell, Property Owner
Prepared by: Conservation of Historic Building Materials Class
Georgia State University, Fall 2013

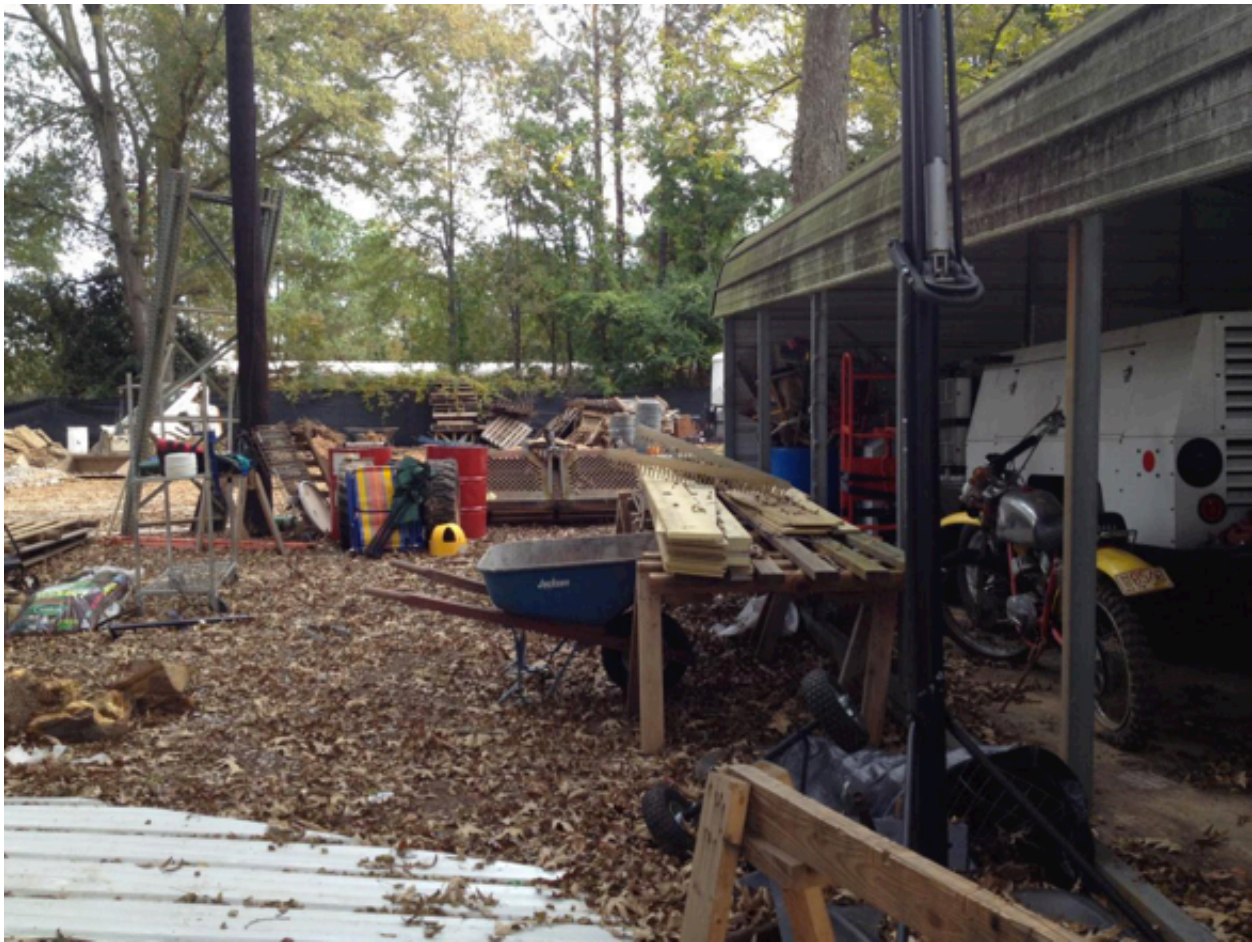
The non-historic carport is in good condition though there is a significant amount of leaves and dead tree limbs that have been deposited on the roof by the trees above as shown in Figure 4.6. Because the carport and the office are beneath several trees that line the eastern border of the property, the likeliness of natural debris falling on or around the structure and causing future damage is high. Since most of the carport is not covered, there is a potential risk that high winds could blow the loose material surrounding the carport underneath the roof or through gaps in the structure, thus damaging its valuable contents as shown in Figure 4.7.

Figure 4.7: Loose materials north of carport.

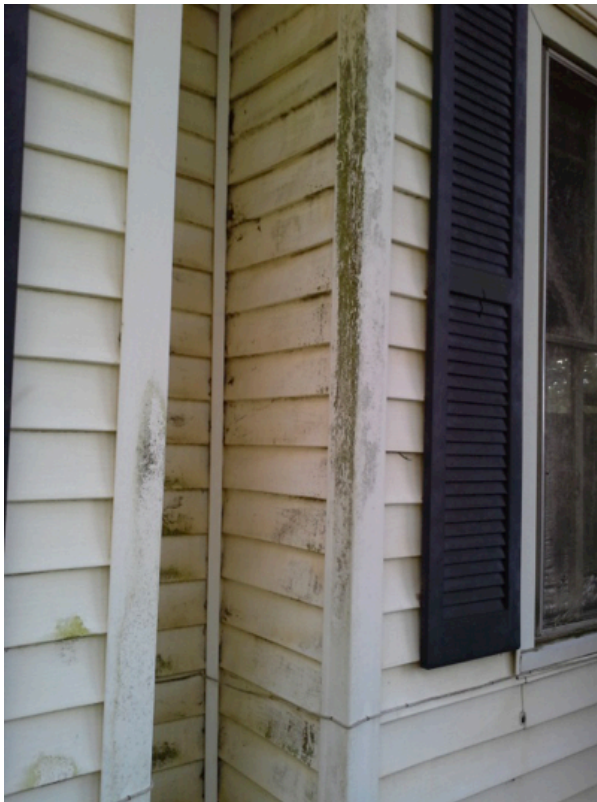
house or there are additions or surfaces changes within primarily shaded regions shown in Figure 4.10 and Figure 4.11. The historic-brick mortar on the porch and the wood ionic columns on top of Portland-cement pads, have considerable damage caused by the constant shade. The wood bases of the columns, especially on the northwest and southwest corners, have considerable damage due to the damp environment and the lack of breathability of the cement pads as shown in Figure 4.4 and Figure 4.12. The paint is also peeling on the full height of the columns.

Figure 4.10: Zones of moisture damage on the north side facing southwest

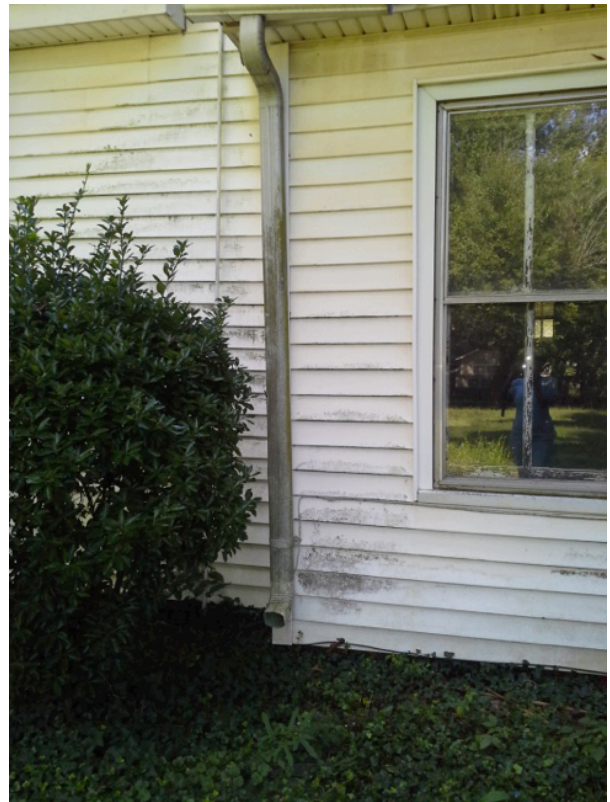
Figure 4.11: Zones of moisture on the north side facing south

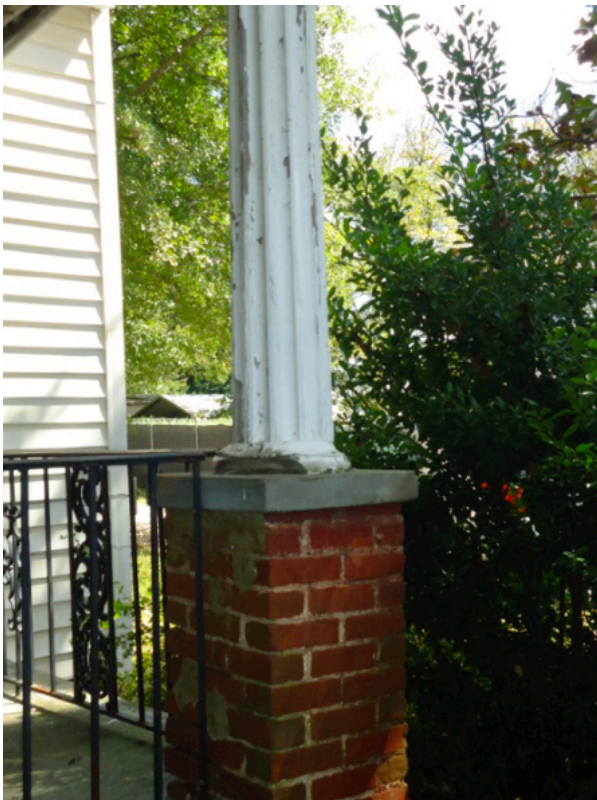
Figure 4.12: Southwest column damage.

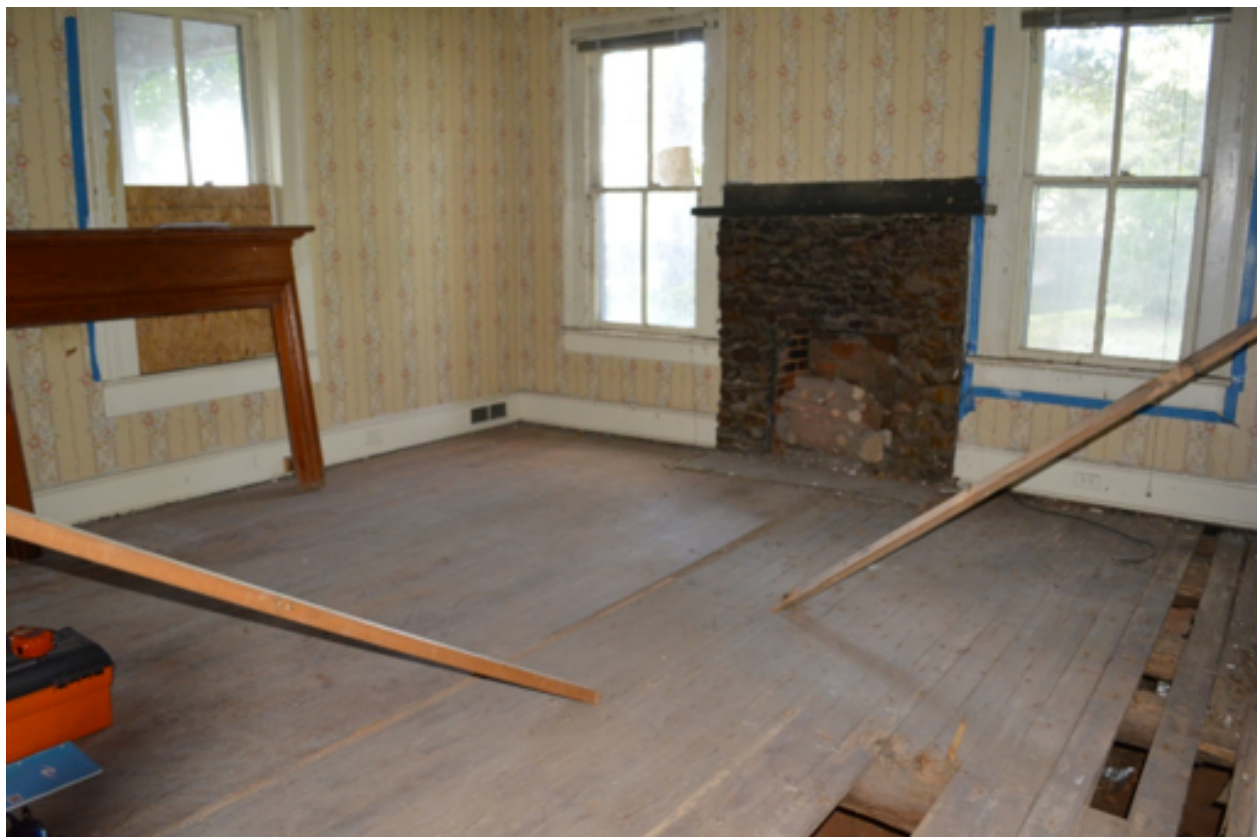
In room 101 the panels from a modern drop ceiling were removed with the wood framing left intact. Taking out the panels revealed the original, wood ceiling approximately one foot taller than the drop ceiling. The original ceiling shown in Figure 4.13 appears to be entirely intact and in good condition, though further investigation will be needed to confirm that assessment. One of the greatest historic features of the Moore House are the original pine wood floors and the joists made from un-milled logs, which support the floor; however these are also the features most in need of attention. There is no sub-flooring below the original, pine floors, which has made the floor particularly vulnerable. The original pine, tongue-and-groove boards are attached directly to the log joists, which have significant termite damage as shown in Figure 4.14. The termite-damaged joists and flooring have left the floor structure soft and vulnerable. The points where the floorboards and joists meet have the most concentrated damage as shown in Figure 4.15. This is caused by moisture trapped between the floorboards and the joists, which would create an attractive environment for insects and mold. Additionally, there is a second, more modern wood tongue-and-groove flooring on top of the original shown in Figure 4.16, which will need to be removed to assess the condition of the original floors for the entire room.

Figure 4.16: Modern flooring and historic flooring in Room 101.

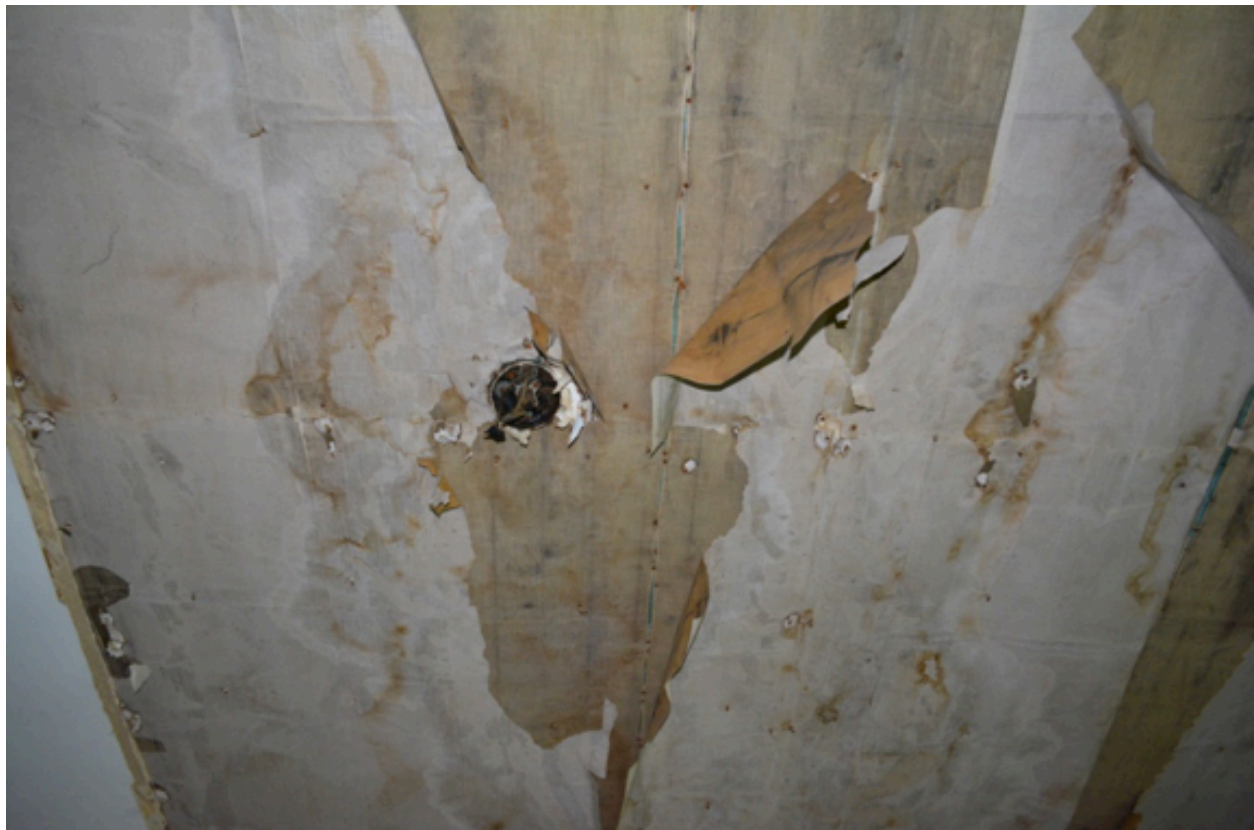
Gypsum boards were torn off from three quarters of the ceiling exposing the original historic wood ceiling covered in peeling paper. There is significant water damage to the ceiling, possibly caused by faulty plumbing from the second floor above shown in Figure 4.18. There is also considerable water damage on the ceiling at the pop-out for the windows shown in Figure 4.19.

Figure 4.18: Ceiling of Room 102.

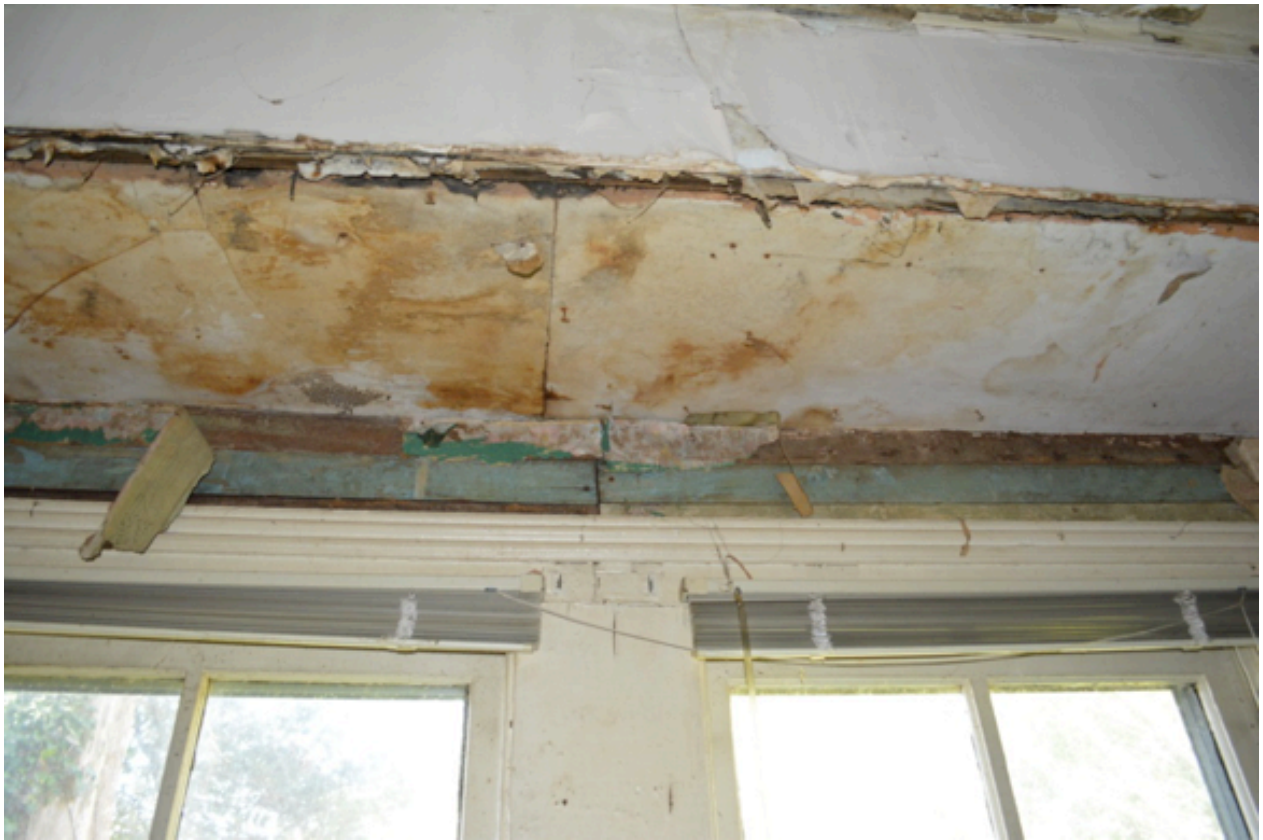
Figure 4.19: Ceiling of Room 102 at pop-out with windows.

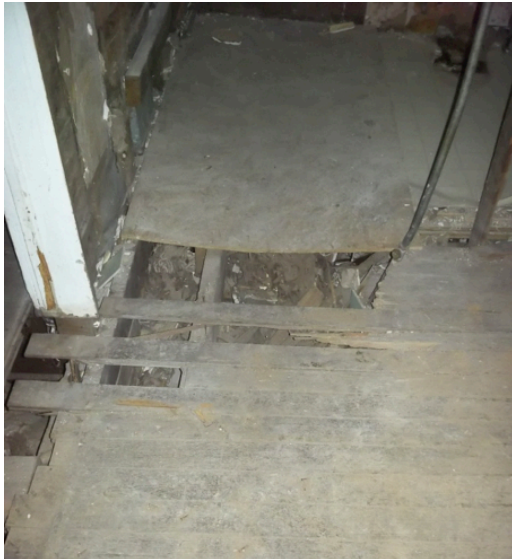
The historic-pine-wood floors in hallway (Room 104) are severely damaged and deteriorating as shown in Figure 4.27. There are missing boards leaving holes throughout the flooring. It should be noted there is no subflooring, which would have provided a protective layer between the floor and the joists. The deterioration could be caused by water damage from leaking pipes and termites. The hallway is next to Room 105, which was once a bathroom and appears to have had plumbing leaks, which could have contributed to the destruction of the floors. The walls at the end of hallway (Room 106) have large holes punched through the drywall as shown in Figure 4.28.

Figure 4.27: Room 104 historic pine floors deteriorated and rotted leaving large gaps and damage throughout the floor.

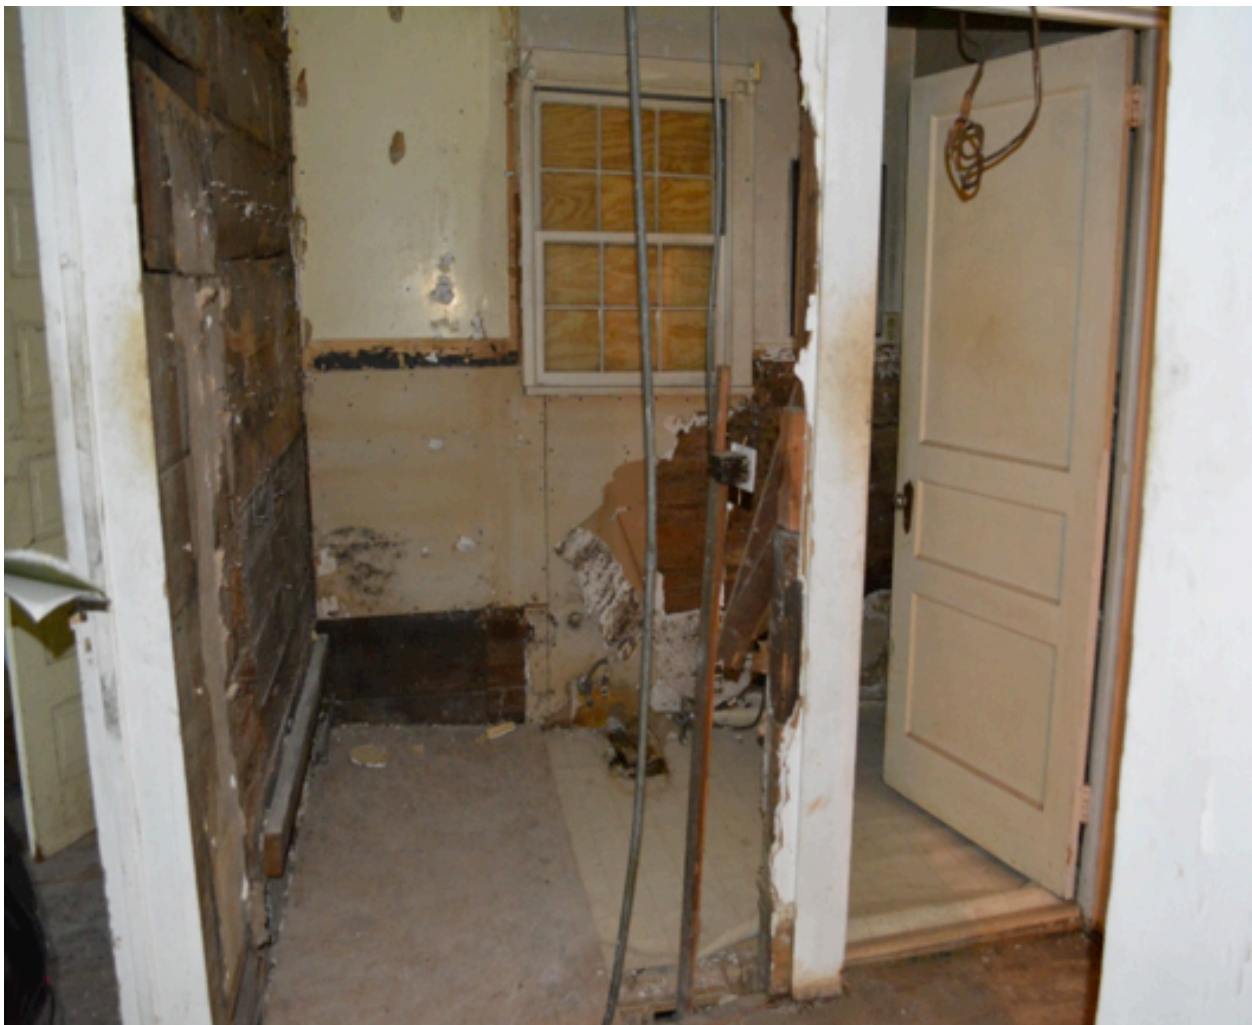
The floors in Room 105 are partly gone, leaving large holes and gaps, covered with plywood. The floor is weak and soft where the wood floor remains and is a hazard. This former bathroom may have had plumbing problems that caused significant water damage to the floors, both wood and vinyl flooring. The vinyl is peeling and has water spots. It is possible the floor covered by the plywood is the location of the previous shower or bathtub. Plumbing issues from the shower or tub are likely the reasons for this part of the floors having such significant deterioration, causing rot and attracting termites. There is also termite damage and cubical rot on the north wall, both indicating persistent, remaining moisture. The walls are in a very poor condition with some boards broken or missing. The wood walls appear to be historic; some of boards are stripped bare while remnants of paint and wallpaper remain. The walls are covered in nails that once held up the drywall, which has been torn out of the entire north wall, though some drywall remains on the east wall, exposing more wood walls shown in Figure 4.29 and Figure 4.30. The plumbing has removed, but a few pipes remain.

Figure 4.29: Room 105 wall conditions.

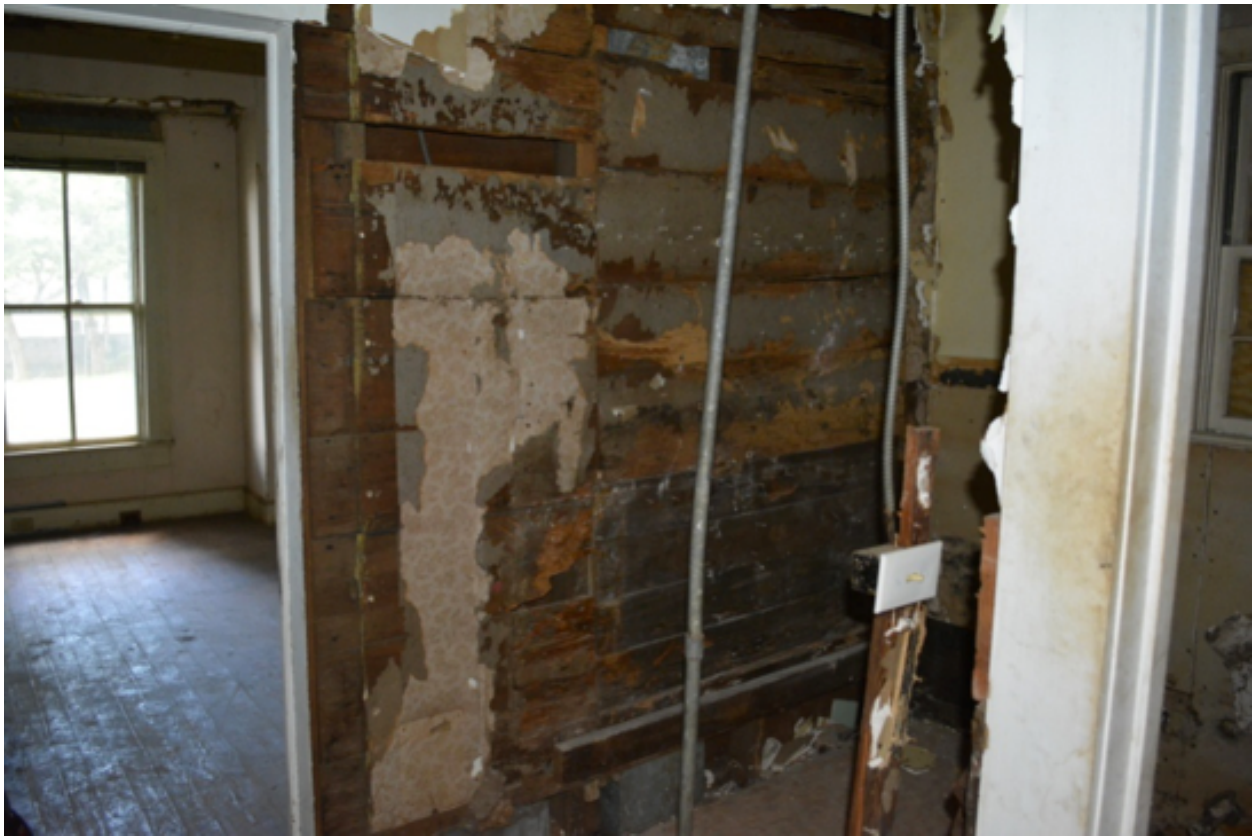
Figure 30: Detail of walls in Room 105.

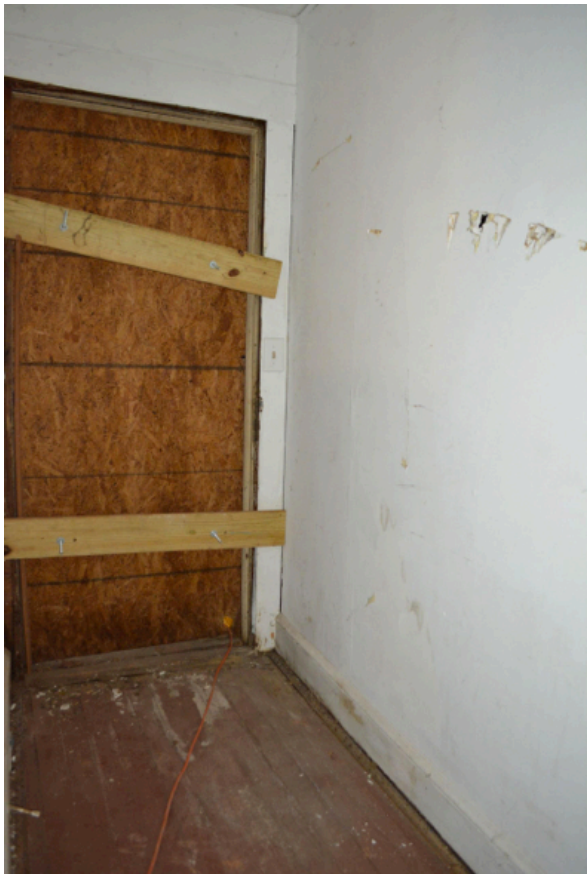
Figure 4.31: Room 106 facing east to the boarded up door leading to room 111.

Room 106 is a hallway that currently leads to the garage (Room 111) (Figure 4.31). The door is boarded up with plywood boards. The walls have gouge marks and holes at the wall opposite the door. The original, pine, floors are sturdier than floors in other areas of the home; however they still merit further analysis to determine if they suffer the same water and termite damage other areas of the first floor are experiencing.

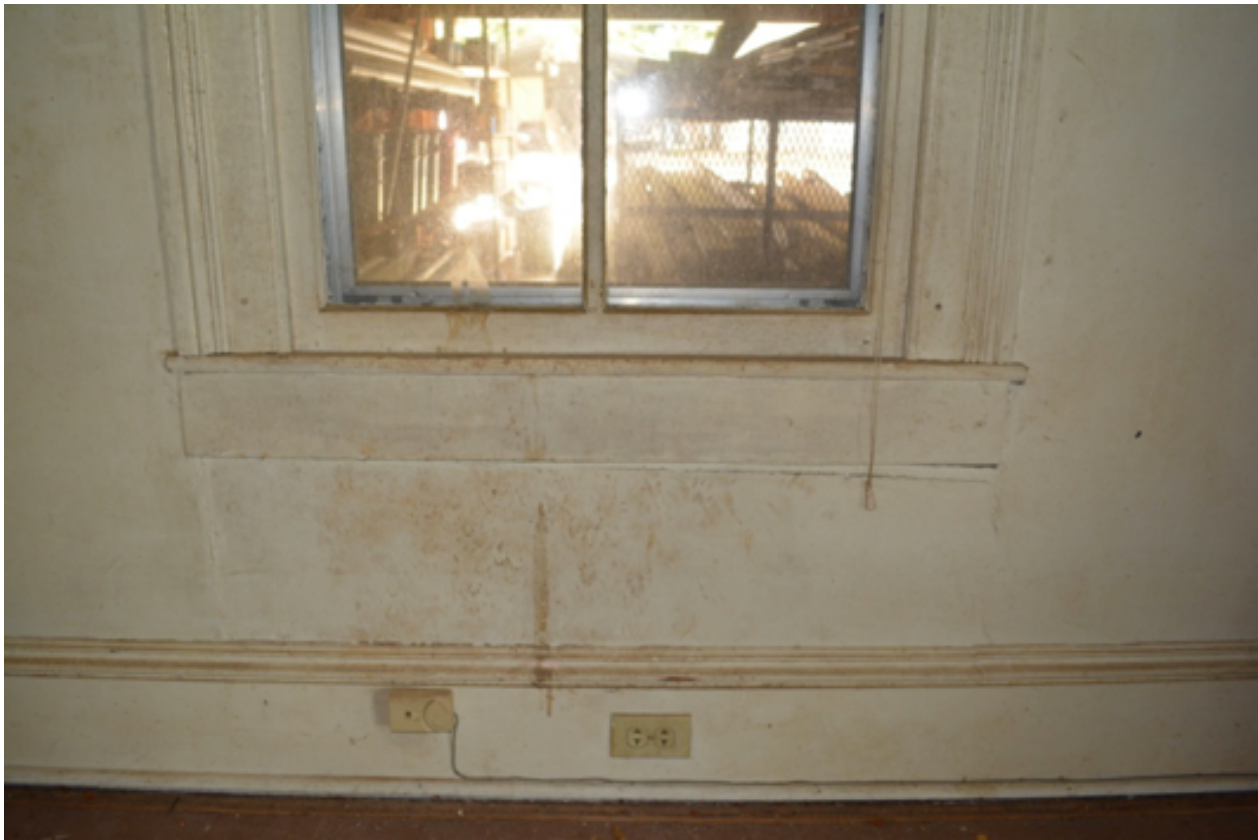
The wall on the north side of the room has holes punched through it as shown in Figure 4.34. The walls are soiled and show remnants of raccoons and cat paws marks on the walls and windowsills shown in Figure 4.35. The inside doorknob to the room door is missing. The window on the east side has a modern, metal frame, either a screen or a storm window on the outside, which diminishes the historic appearance of the window.

Figure 4.35: Soiling on the windowsill and wall of Room 107. View into Room 111.

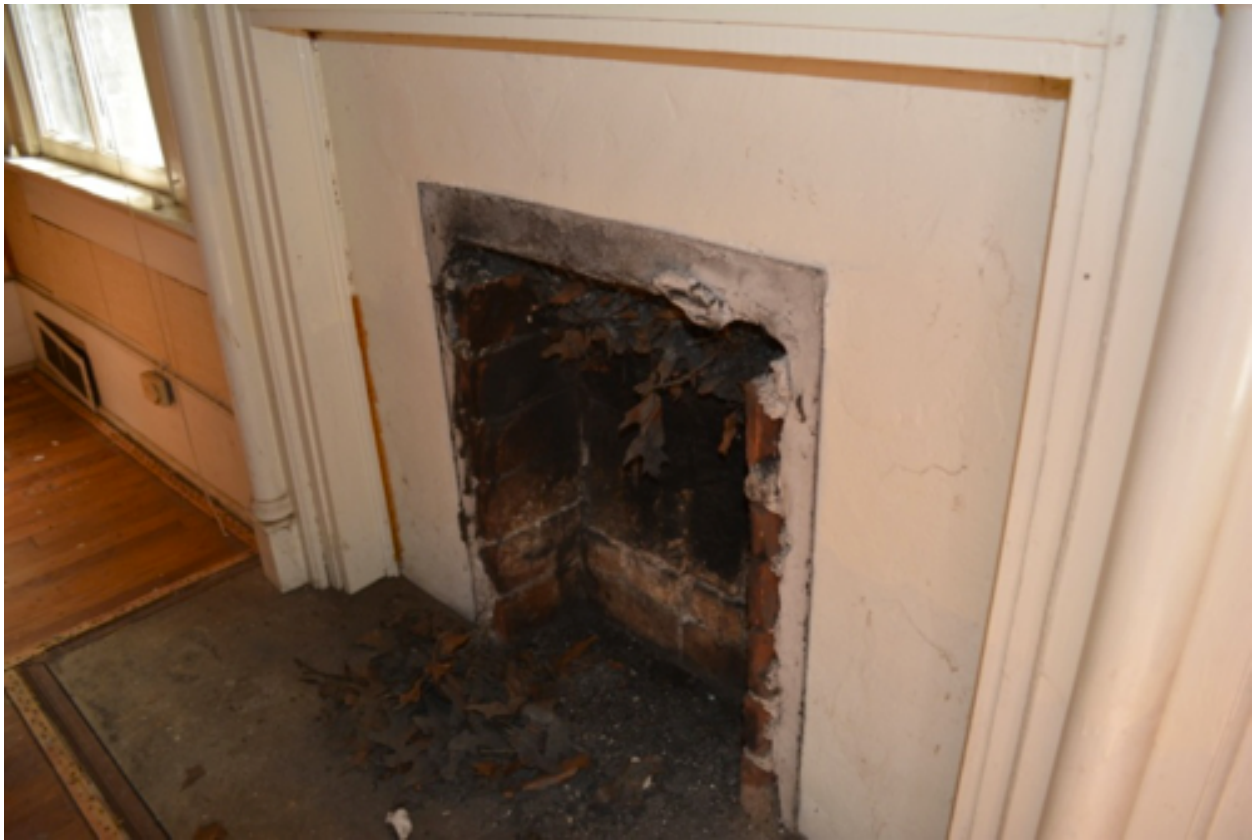
The fireplace has been altered at some point in order to accommodate burning coal, making the firebox shallower. The bricks are historic bricks; however they were installed or patched with Portland cement as shown in Figure 4.36 and Figure 4.37. The bricks are separating from the mortar, because Portland cement is a more rigid material forcing the historic bricks, made of softer material, to separate and eventually fall out. The fireplace also is stuffed full of rotted leaves indicating an opening in the chimney.

Figure 4.36: Fireplace in Room 108.

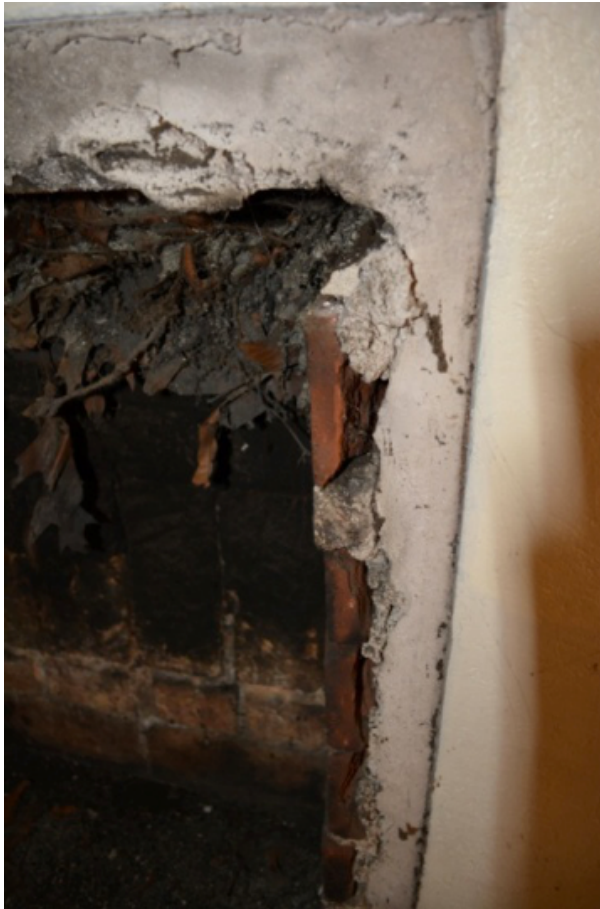
Figure 4.37: Detail of patch with Portland cement.

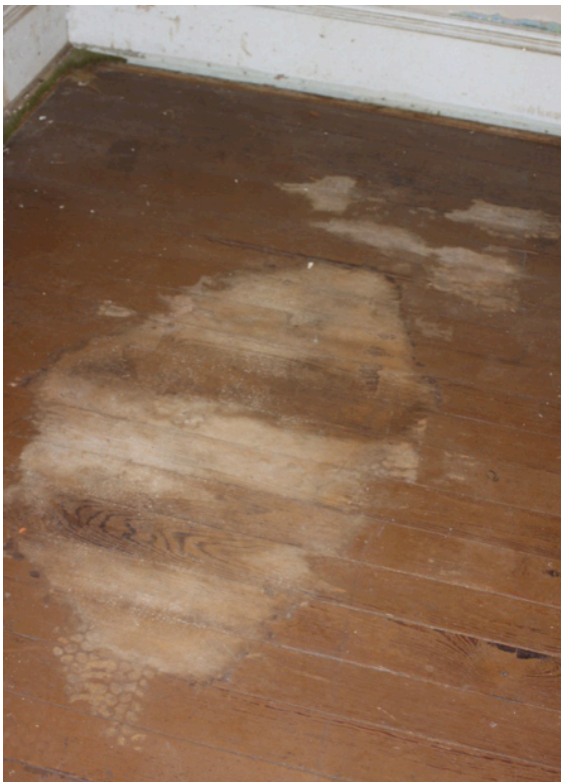
Located in the northwest corner of the house, Room 201 has significant water damage in the flooring. A hole in the attic above Room 201 is causing this deterioration. There is also evidence of animal damage areas of the wall. The molding is missing around the windows close to Room 208. The ceiling is made of paneling. Layers were removed to reveal that the walls are made of layers of plasterboard. The paint is peeling off a large section of the western wall in response to moisture leaching into the wall from damaged, exterior, vinyl siding Figure 4.38. There is extensive wear and damage to the painted, wood, floor in the northeast corner as shown in Figure 4.39.

Figure 4.39: Northeast corner of Room 201, depicts flooring with moisture damage caused by hole in the attic.

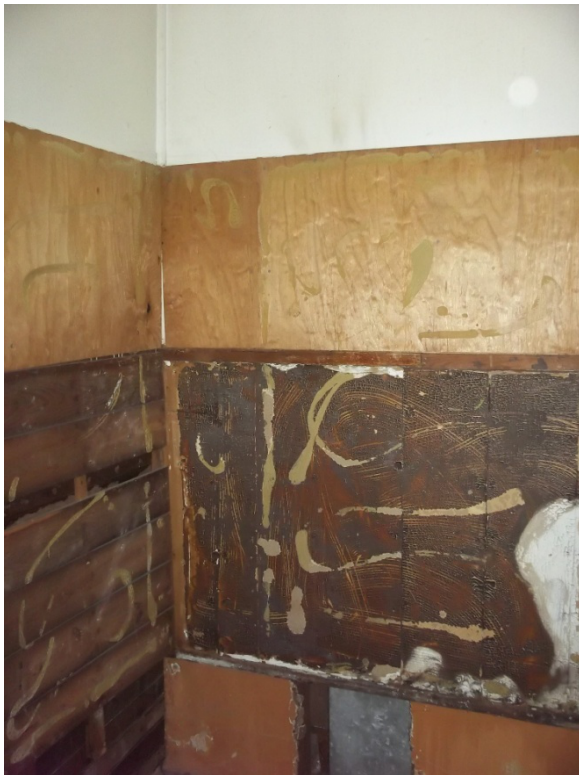
This room was gutted and is in poor condition, no fixtures remain. The floor is mainly composed of oriented strand board (OSB), plywood and modern cut boards, which may be covering older layers of flooring. The walls are a mixture of OSB, plywood and modern boards secured with machine made, wire nails. There are glue marks on the walls as shown in Figure 4.42 that were used to secure the ceramic tile up to just above where a tub would have been. It can be concluded that this room was a bathroom. The window in this room is one of two six-over-six window in the house, the other one is in Room 105, the former first floor bathroom.

Figure 4.42: Southeast corner of Room 203.

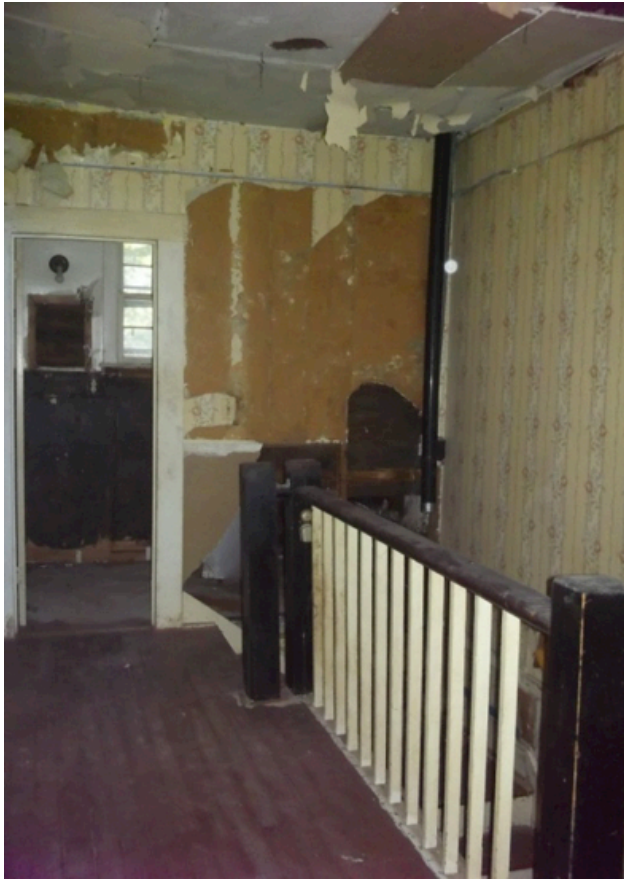
The second floor is accessed by a centrally located L-shaped stair. The stairs were once carpeted, and the carpet tacks remain. The original, wood floor is visible with baseboards along the side. A modern banister is attached to one of the wallpapered walls. The wallpaper, some of which is pulling away from the wall, and the wood floors continue in the upstairs hall. Colonial style baseboards run throughout the second floor. Plain molding surrounds the doors, these features are missing or replaced in parts. The floor in this room is in good condition; carpet tacks remain around the perimeter of the room. There is a strip of plastic attached to the walls, at such a height that it suggests a picture molding, but its purpose is unclear. The ceiling in this room has been damaged by moisture and a large hole has been cut into it, potentially associated with the installation of a drop ceiling. The end posts of the banister are squared, and show reciprocal saw marks, a sign this banister could have been installed as early as 1850. The dropped ceiling is heavily deteriorated as shown in Figure 4.43 and Figure 4.44.

Figure 4.43: Room 204 facing west.

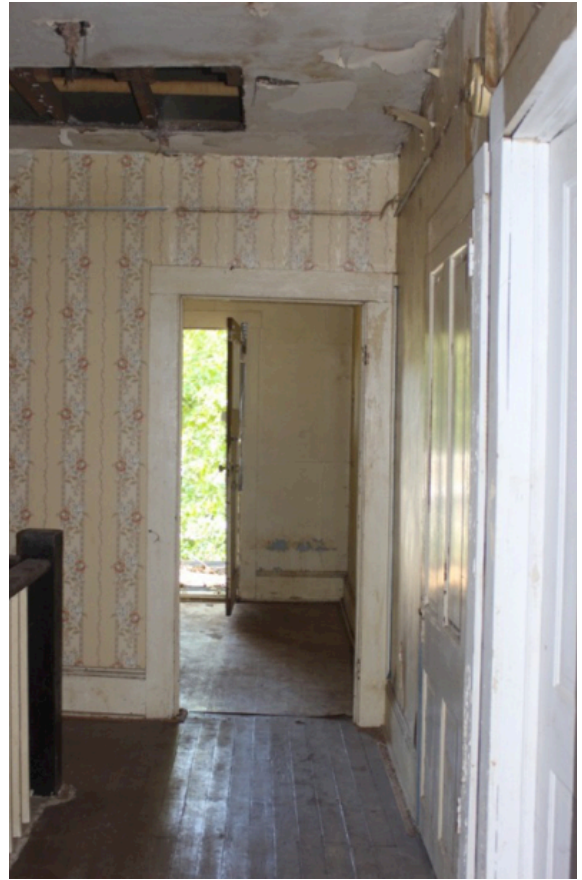
Figure 4.44: Room 204 facing east.

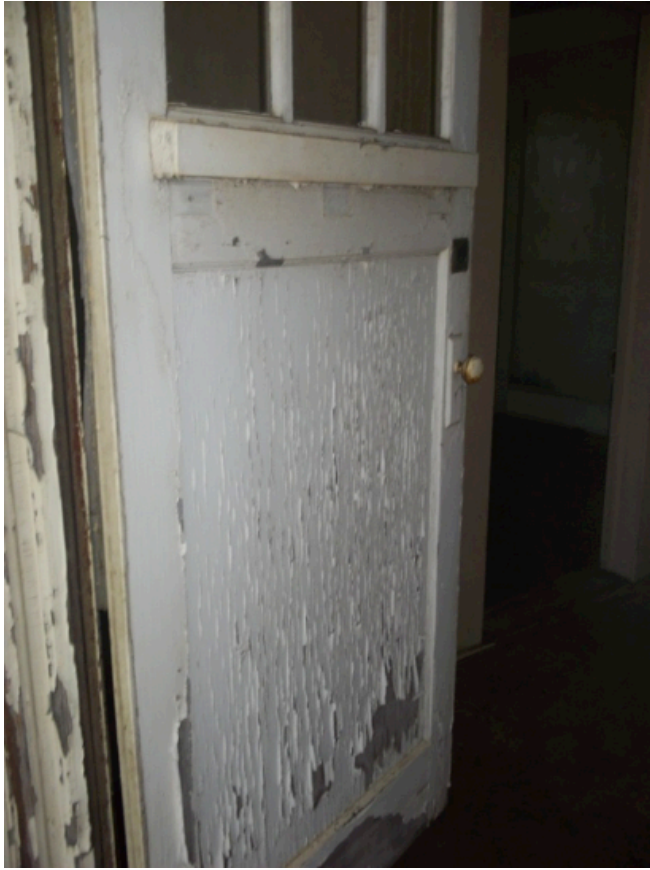
Room 207 opens into the hall (Room 204) and onto the roof of the porch. The exterior door is painted wood with three-lights over one-panel. The paint on the exterior side of the door is peeling from exposure to humidity, heating, and cooling cycles as shown in Figure 4.47. The paint has curtailed damage to the door. The floor is a layer of vinyl, covering a newspaper (dated June 8, 1961). Both the newspaper and vinyl cover wood flooring. The colonial baseboards are present, and there is a crown molding along the four walls. The door casements are square and simple. The walls and paint are mostly intact, with a small hole near the southwest corner and some peeling paint as shown in Figure 4.48.

Figure 4.47: Exterior door into Room 207. The paint has protected the door from moisture damage.

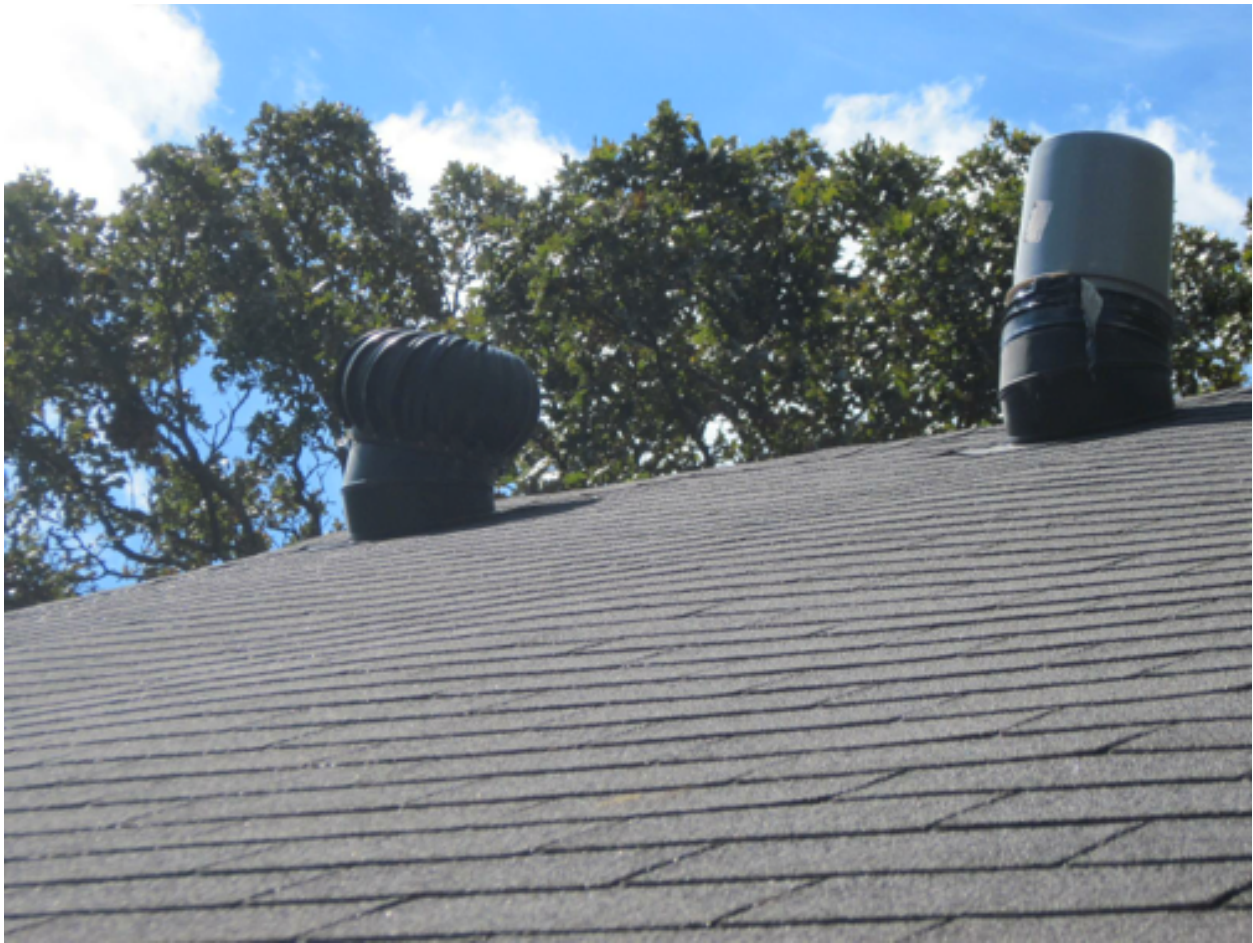
can vent covers need to be replaced to allow for better ventilation (Figure 4.53). The roof on the bay addition, on the northern façade, is beginning to rot. Likewise, the soffit on the shed roof is completely rotten. It is evident the roof and the original chimney began to separate because an effort to rejoin them was made by filling the hole with asphalt (Figure 4.54). However, the asphalt is cracking which has formed a hole.

Figure 4.53: Turban vent and trash can vent cover on hip roof facing west.

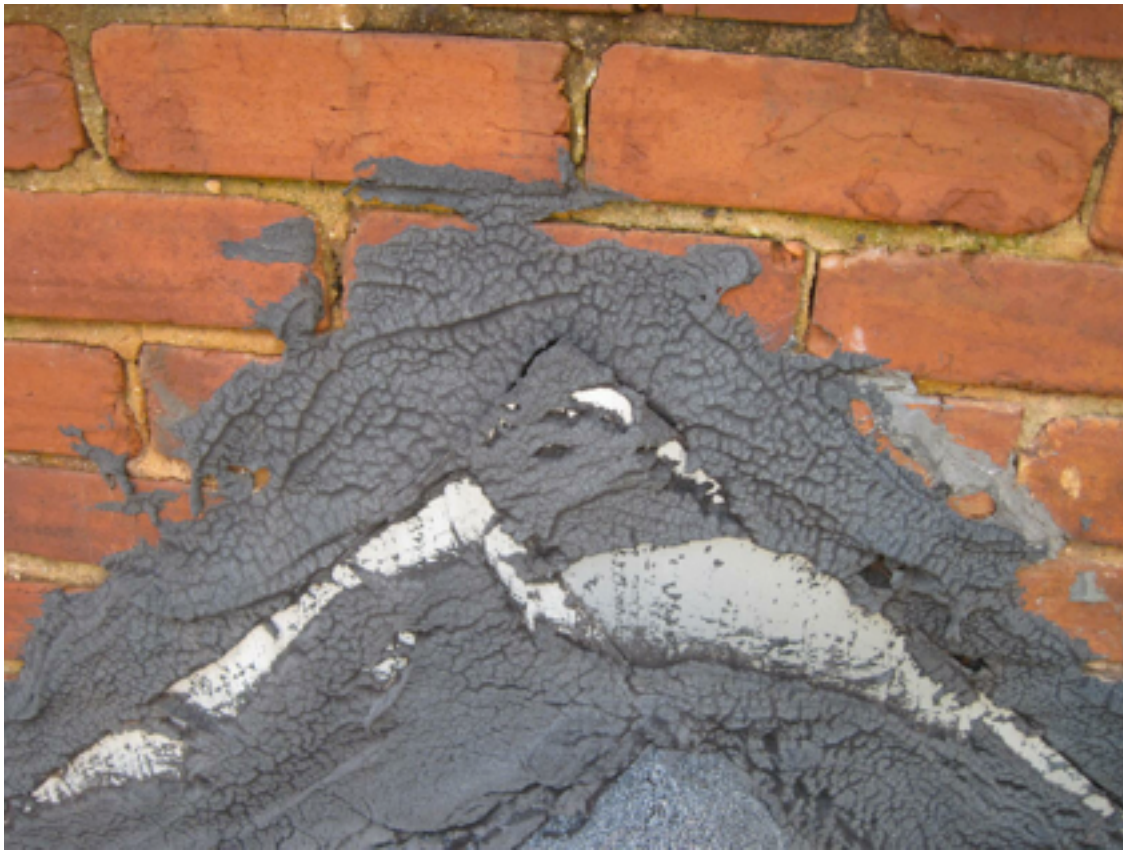
Figure 4.54: Historic saddlebag chimney on east facade patched with multiple layers of asphalt.

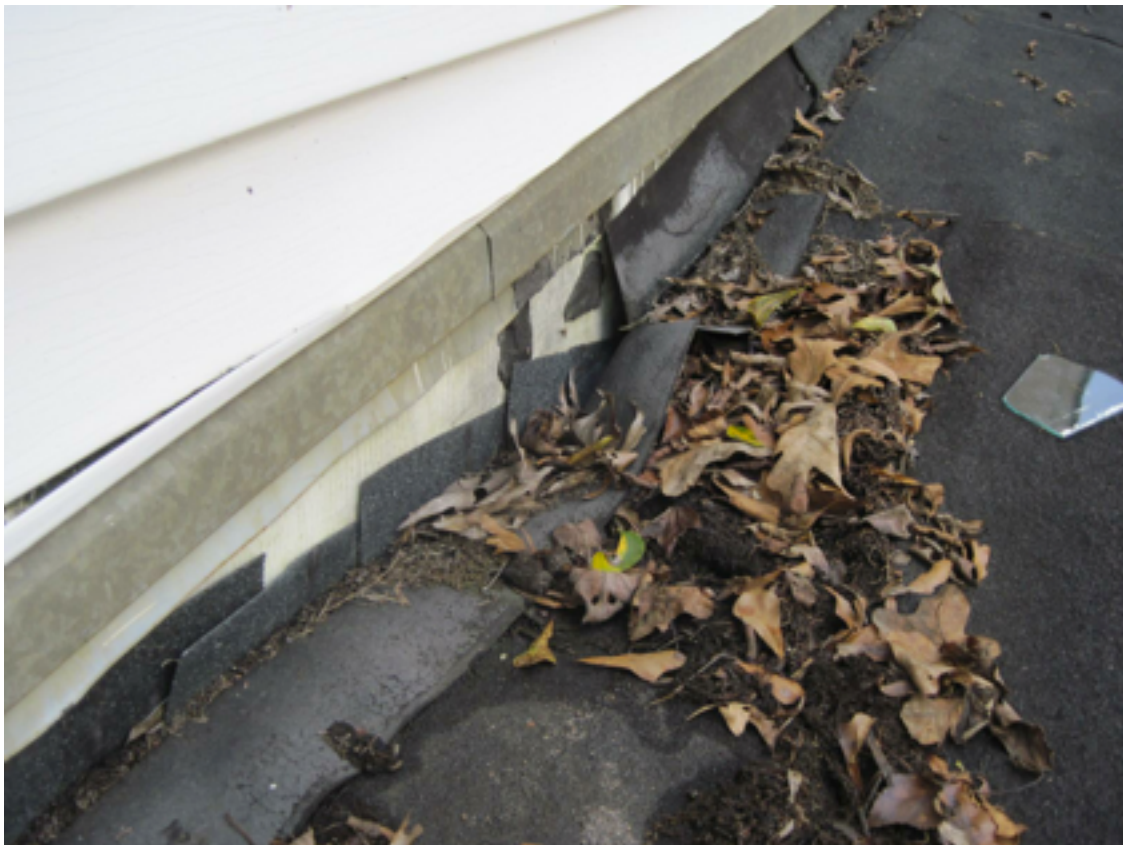
The porch roof consists of an asphalt sheet attached to metal flashing, which is attached to the vinyl siding on the house. This roof is full of debris such as tree limbs and leaves. Last but not least, all of the gutters and down spouts are either broken or full of debris (Figure 4.55). This can become dangerous when it rains because there is some evidence of electricity in the house and these wires are exposed and next to the gutters on the northwestern and southwestern sides of the house.

Figure 4.55: Look north on roof near room 205 showing close-up of debris build-up.
